Small village systems - Villa Las Araucarias

E. Ian Baring-Gould
National Renewable Energy Laboratory
Golden, CO. USA

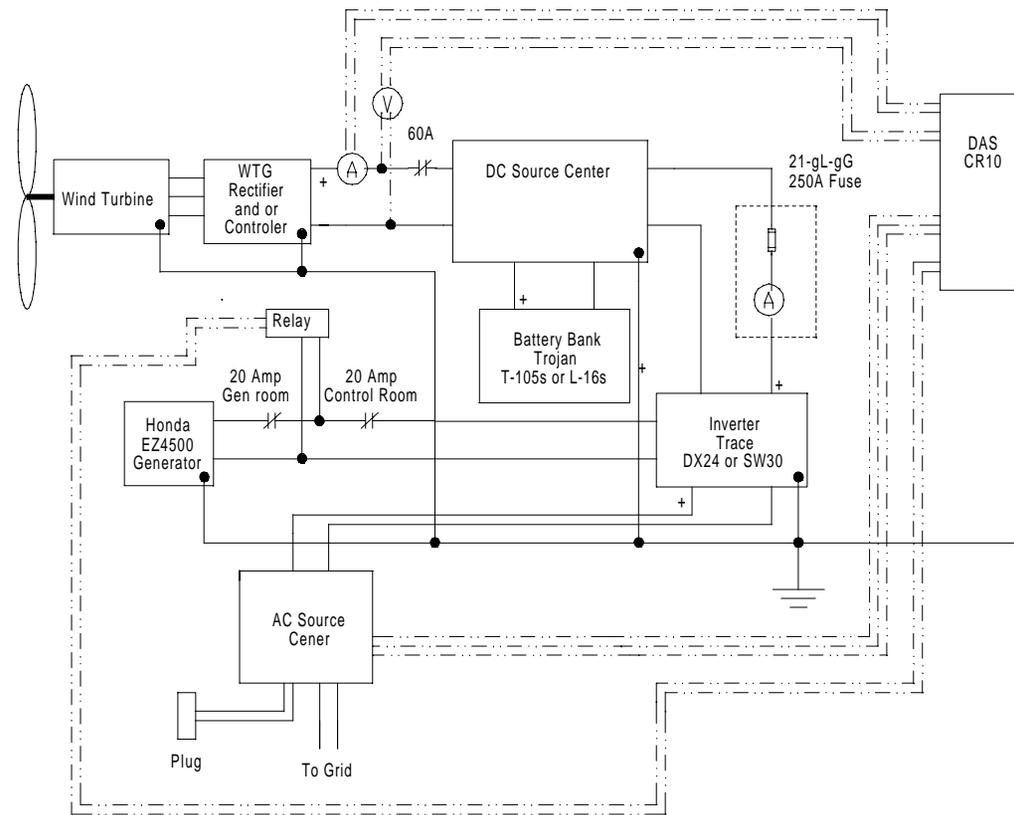
Basic System Design

Power System Components

- **Bergey Windpower Excel 10kW wind turbine**
- **33.6 kWh battery bank of Trojan L-16's**
- **Trace Engineering SE3024E inverter**
- **Honda EM4500S 5.4 kW auto-start gasoline generator**
- **48 Volt DC bus with no DC loads**
- **220 V, 50 Hz AC distribution on a 0.91 km grid**
